Technical Bulletin: Appearance of Cracked Glass

MKF-68 Rev 08152016

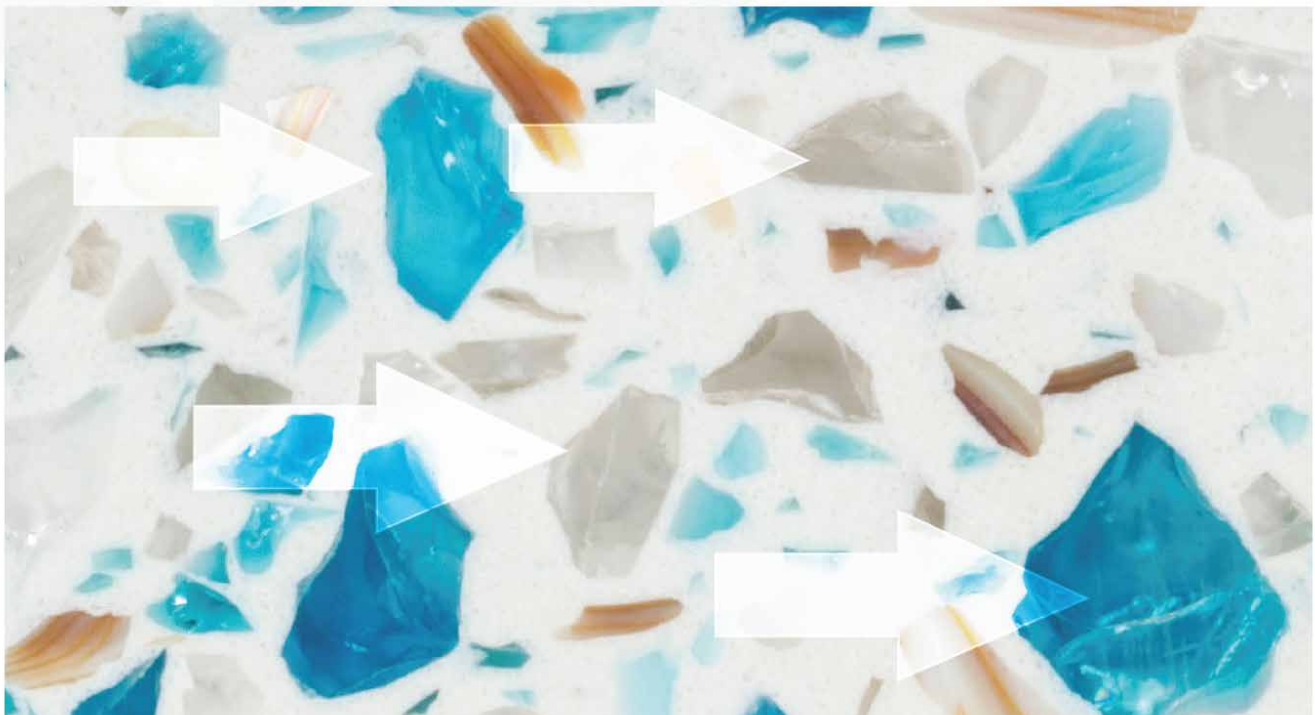
The process used to create GEOS Recycled Glass Surface includes a vibro-compaction process that aggressively vibrates and compacts the ingredients to give them a very tight, durable surface. During this process internal fissures can appear in the larger pieces of glass. These are superficial and do not affect the performance of the surface.

Due to the recycled glass content in GEOS Recycled Surfaces, there may be minor variations in the surface of the glass that can be felt with a bare hand. These are part of the aesthetic and are not a defect unless they are deeper than 1/16".

Example of cracked glass in surface.
