Technical Bulletin: Appearance of Sea Shell Erosion

MKF-69 Rev 05252021

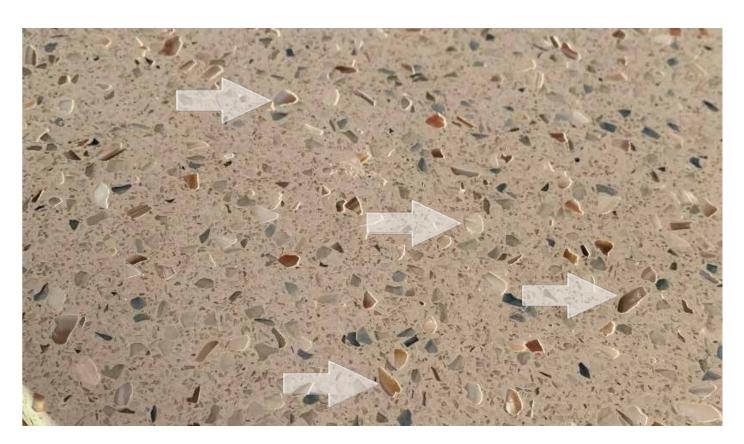
High acidity substances are known to chemically break down the calcium carbonate in sea shells. The exposed sea shell in a GEOS Recycled Glass Surface is no different. Spills or cleaning products containing high acidity (such as lemons or vinegar) if left for a prolonged period or applied routinely may cause damage to GEOS colors containing natural sea shells.

This damage is easily identified when minor variations in the surface can be felt with a bare hand. Upon closer examination, the height of the recycled glass and high performance resin will appear constant with shallow voids **ONLY** affecting the sea shell particulate.

Example of sea shell erosion on a GEOS Recycled Glass Surface.

Such texture that only affects the sea shell particulate in a GEOS Recycled Glass Surface is **NOT** considered a material defect but rather the result of an environmental factor or interaction. In most cases, selecting an alternative cleaner may be all that is required to stop further erosion of the sea shell in a GEOS Recycled Glass Surface installation.
